Company	Trenz Electronic GmbH
PCN Number	PCN-20240207
Title	Pull-up resistor removal for signal "MR"
Subject	BOM Change
Issue Date	2024-02-07

PCN-20240207 TE0821-01 Pull-up resistor removal for signal "MR"

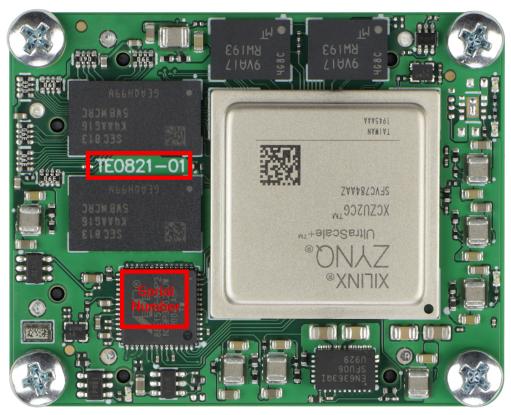
The model code and revision number (TE0821-01) are printed on the top side of the PCB. The serial number is written at the QR-code on the top side label on top of IC (U8) marked with a red frame in picture below.
