<b>Company</b>	Trenz Electronic GmbH
<b>Number</b>	AVN-20211202
<b>Title</b>	Problematic MEMS Oscillator
<b>Subject</b>	Information and remedy concerning problematic MEMS Oscillator
<b>Issue Date</b>	2021-12-09

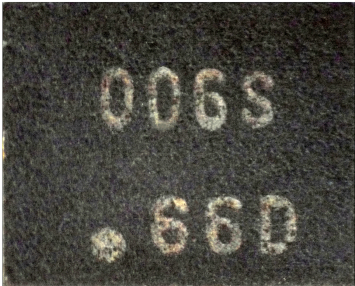
Due to component shortage from June to August 2021 some Trenz Electronic products were assembled with datasheet compatible DSC6111MI2A-025.0000 instead of SiT8008BI-73-18S-25.000000E. Although there is no evidence for any performance issues from the datasheets at least one batch of DSC6111MI2A-025.0000 has been identified to be root of issues in specific applications.

1. Ethernet communication with online available standard reference design is unreliably:
  - a. Standard ping test in separated environment results in package loss of up to 10% or
  - b. unexpected link up/down switches.
2. MGT communication fails, known to work designs showed no link.

possibly affected	not affected
DSC6111MI2A-025.0000	SiT8008BI-73-18S-25.000000E

1. Trenz Electronic opens a RMA and the affected MEMS is replaced at Trenz Electronic.
2. Trenz Electronic sends a SiT8008BI-73-18S-25.000000E for substitution to the customer.
